Alliance Garments Ltd.

20 May 2014

Structural Inspection Report

Observations & Actions

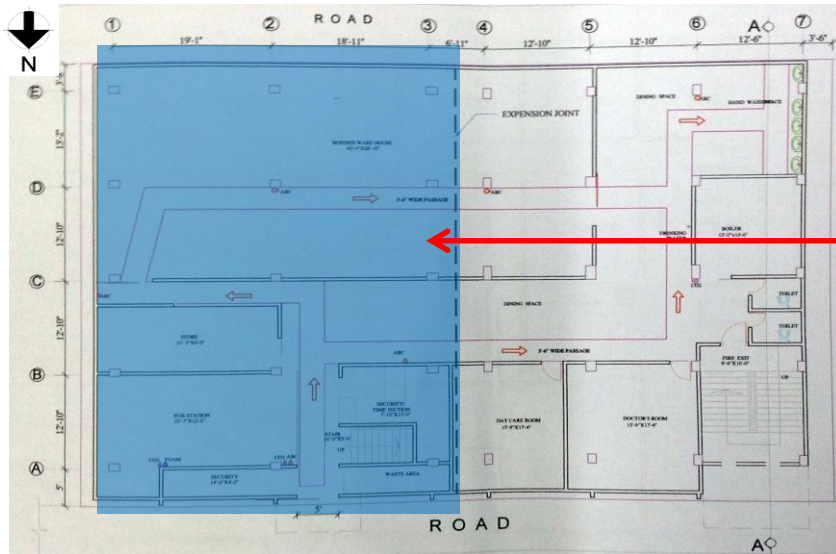
Floor Plan

Columns, within the eastern section of the factory, appear to be stressed in excess of normal design limits

Design check to be carried out on all concrete columns in the highlighted area

- Factory Engineer to review design, loads and column stresses in area identified above.
- Verify insitu concrete strengths (using min. 4 no. 100mm dia. Cores) and existing reinforcement for all columns.
- Produce and actively manage a loading plan for all floor plates within the factory giving consideration to floor capacity and column capacity.
- Update existing floor loading plans to distinguish between allowable and actual imposed floor loads

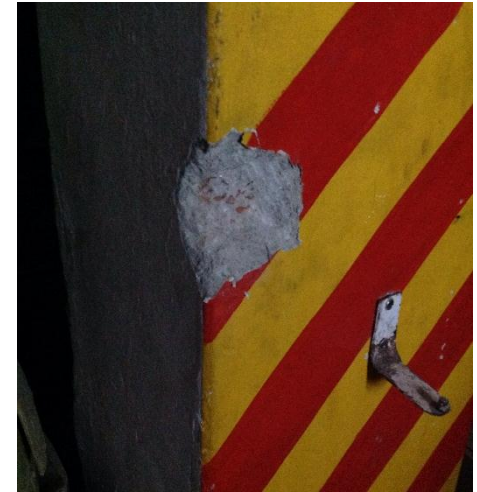
Checked Ground Floor Column – Brick Chips

Outline calculations indicate that column working stress, within the area highlighted on the above floor plan, is in excess of normal design limits

Building Engineer is to perform detailed calculations and concrete tests to prove column size and (if required):

- Reduce loads by vacating floors
- Reinforce columns

Existing reinforcement in columns to be verified on site by Building Engineer

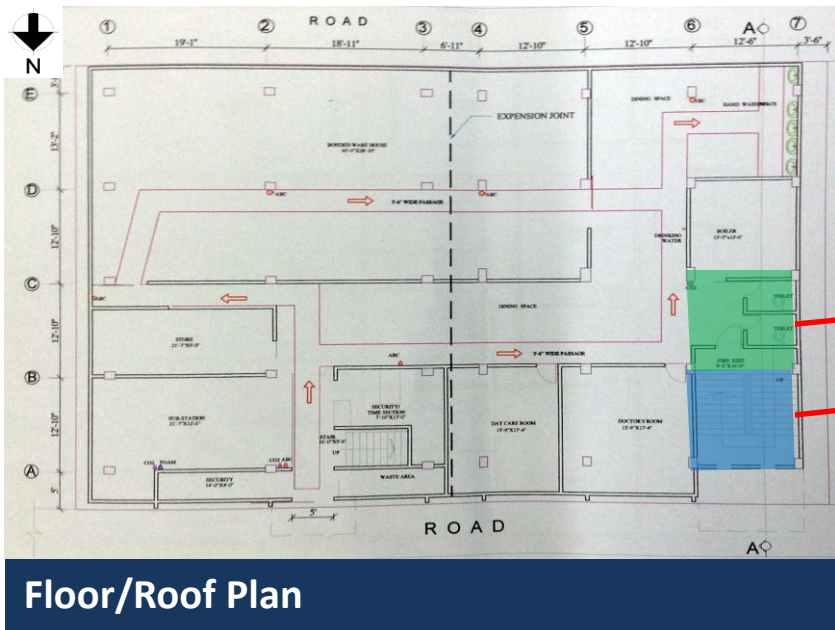
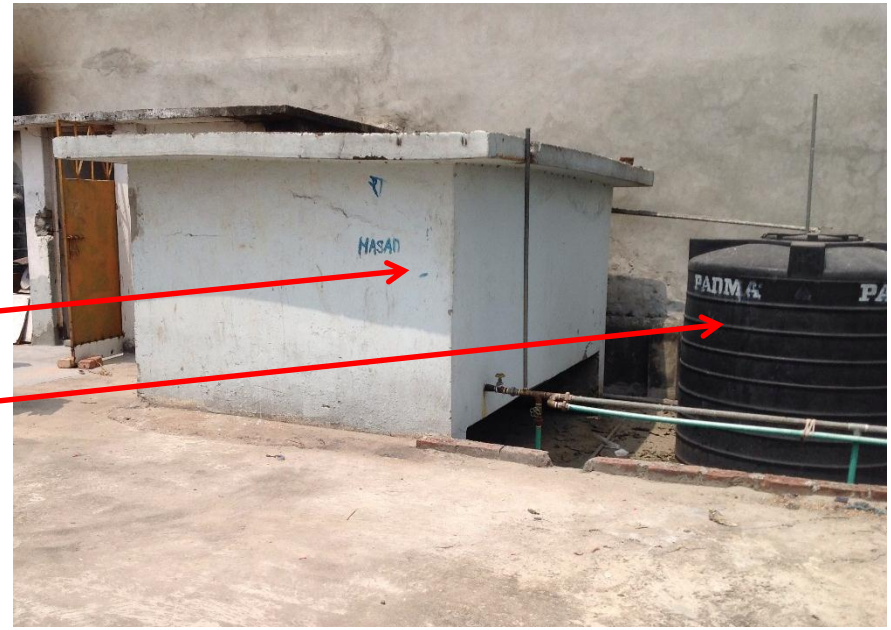
Design check on structure supporting roof top water tanks

Cracking on the walls below the water tanks

Building Engineer to review structural support to concrete and plastic water tanks and confirm the adequacy of this support.

- Extent of roof loading, including concrete and plastic water tanks and water tank support structure, to be surveyed and capacity of roof slab and support system to be assessed to confirm that they are structurally adequate.
- Produce and actively manage a loading plan for all floor plates within the factory giving consideration to floor capacity and column capacity.

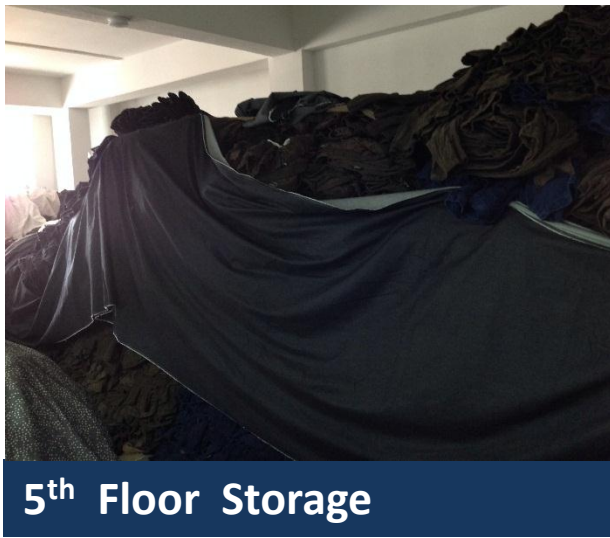
Management of floor loads and design check on capacity of floor slab to support floor build-up loads in toilet areas

5th Floor Storage

Building Engineer to prepare controlled loading plans, based on floor slab and column capacity, for all floors which will designate allowable storage density and where storage may be placed.

- Produce and actively manage a loading plan for all floor plates and the roof of the factory giving consideration to floor capacity and column capacity.

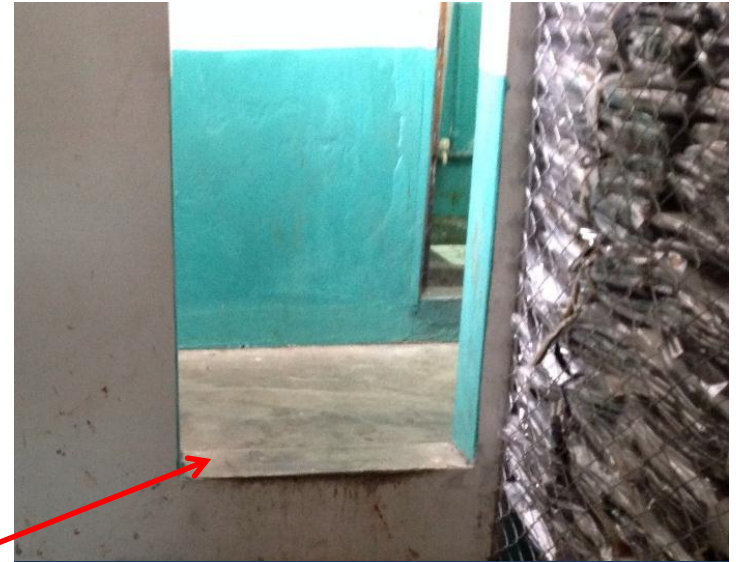
Toilet Floor Build up

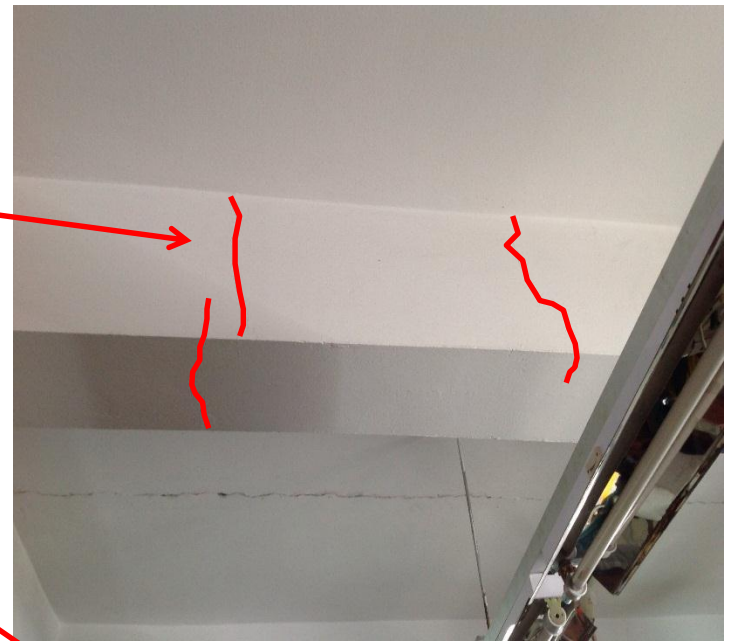
Cracking to beams at underside of roof

Cracking of beams on the soffit of the roof to be reviewed, by removing plaster, to confirm that cracks do not extend into the structure.

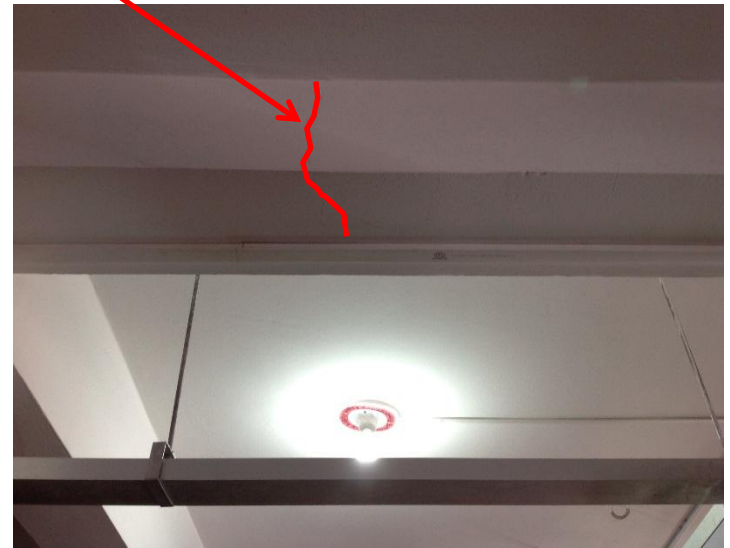
Cracking on Soffit of Roof Beams

- Sections of plaster finish to soffit of the cracked roof beams to be removed to investigate if cracks penetrate the building structure.

- Building Engineer to carry out design check on beams to confirm that these cracks are non-structural.

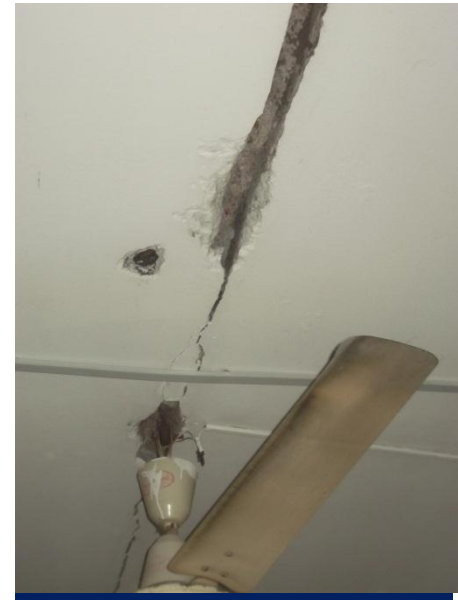
Movement joint evident at all floors

- Building Engineer to inspect internal line of building movement joint and prepare a schedule of areas which require remedial works to prevent risk of falling plasterwork.
- Carry out making good works per Building Engineer schedule including re-weathering of joint line externally to prevent any rainwater ingress.

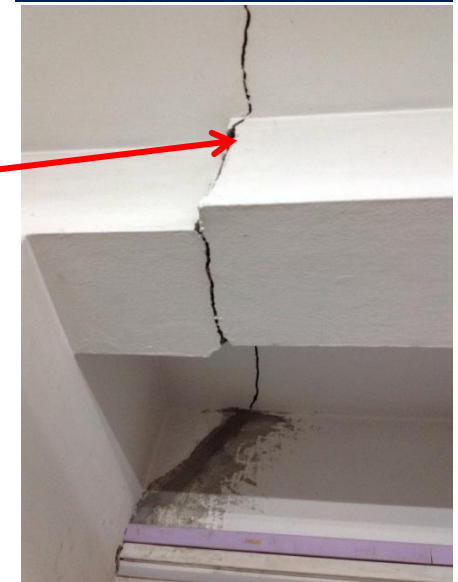
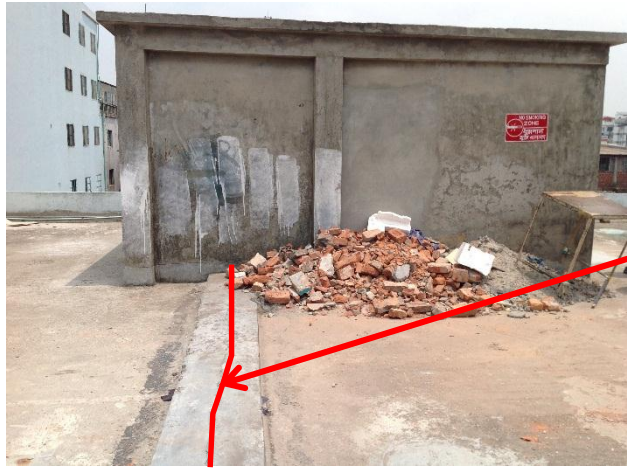
Building Movement Joint

Movement Joint – recommend re-weathering externally to prevent future rainwater ingress
