FIRE SAFETY INSPECTION REPORT

ALLIANCE GARMENTS LTD
HOUSE # 8 & 10, ROAD # 3, SECTION # 7, MIRPUR
INDUSTRIAL AREA, DHAKA-1216

Fire Safety Inspection Report Alliance Garments Ltd

Alliance Garments Ltd manufacturing complex was surveyed for fire safety on 5/5/2014 by Hughes Associates, Inc.

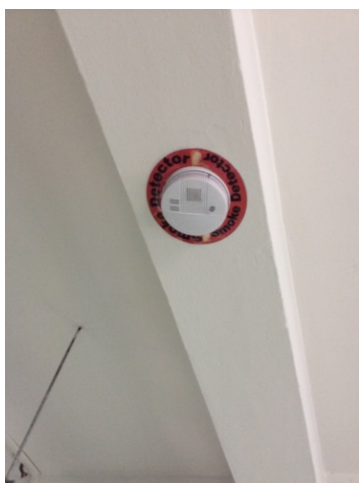
Single station smoke alarms are located in various places throughout the factory. These smoke alarms are not tied into the fire alarm system. In the event they detect smoke, they will provide a local alert sound. There were no records or assertions of regular testing or maintenance of the fire detection system.

Single station smoke alarms

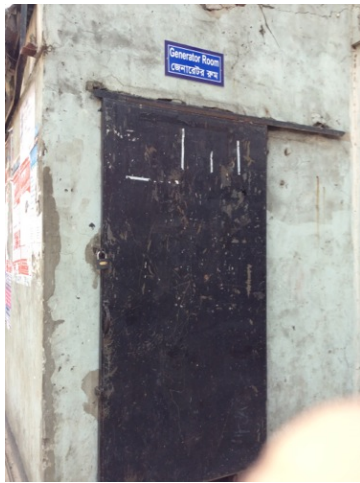
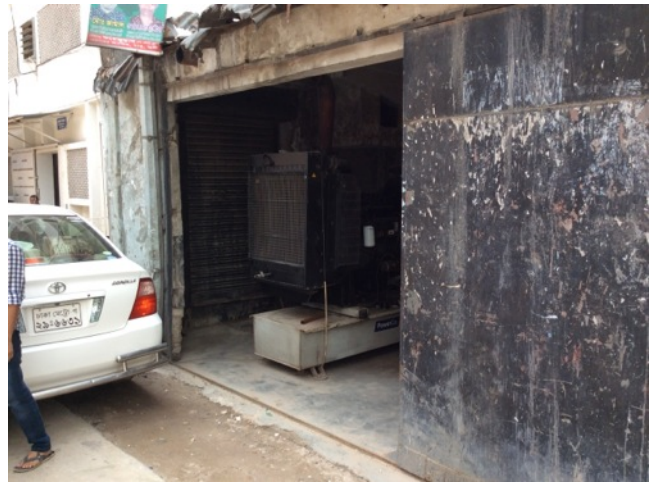
One (1) diesel powered generator serves the building. These generator is located in a separate structure located north of the building. The roof structure is not fire rated.

Generator Room

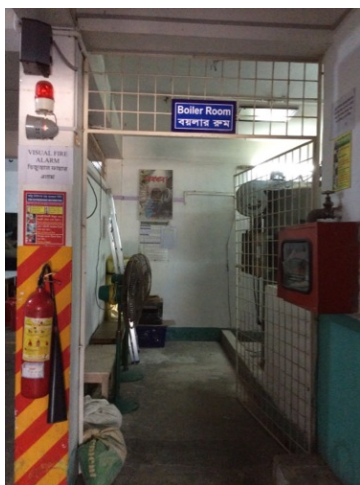
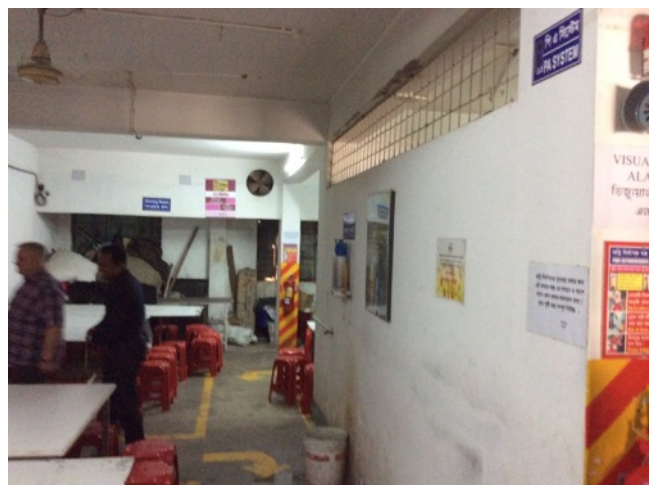
A boiler is located on the ground floor of the building. The boiler is surrounded by partial-height walls without full separation from the factory floor.

Fire Rated Separations Provided? No

Boiler room open to floor

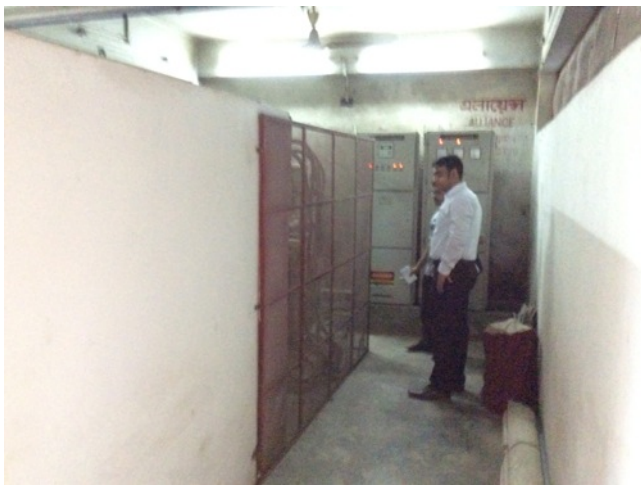
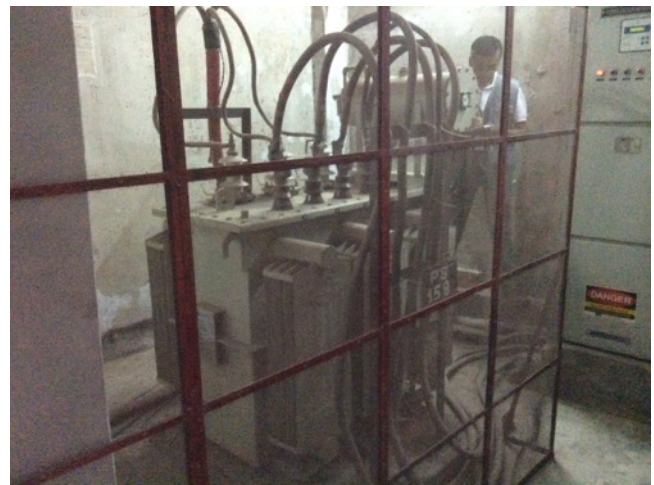
A transformer is located on the ground floor of the building. The transformer is surrounded by partial-height walls without full separation from the factory floor.

Fire Rated Separations Provided? No

Transformer room

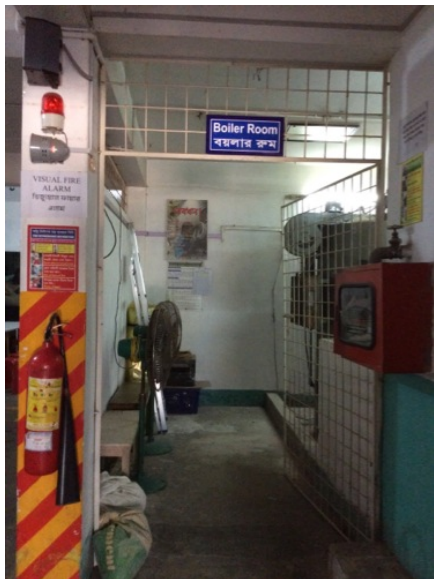
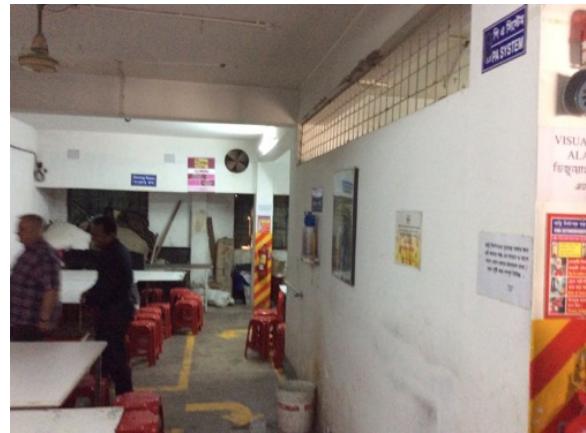
No.	Category	Finding	Recommendation	Remediation Timeframe
F-1	Fire Rated Construction	<p>The boiler room is not separated by fire-rated construction.</p> <p>The boiler room is located in the ground floor next to the dining area.</p>	<p>Separate the boiler room by a minimum 1-hr fire-rated construction. Seal and/or protected all openings to maintain the required fire separations</p>	Within 3 months

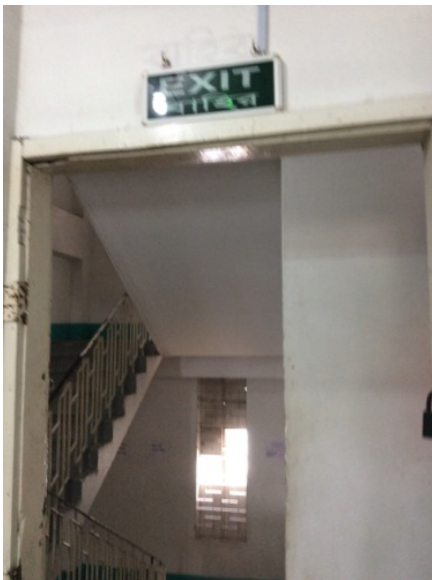
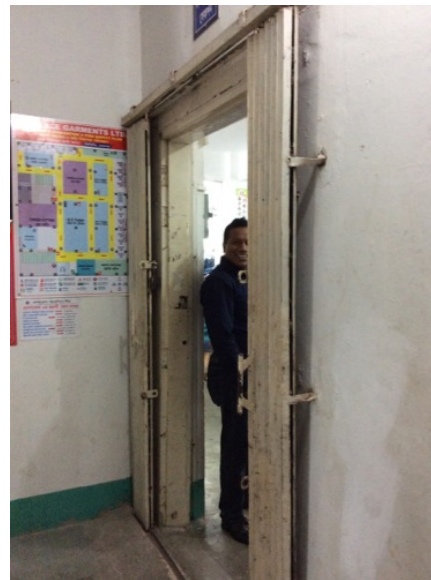
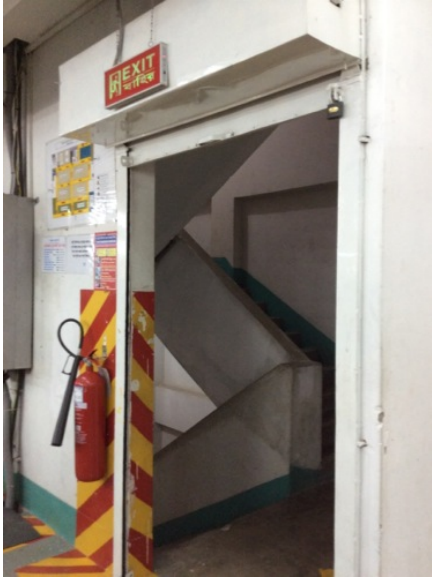
F-2	Fire Rated Construction	The exit stairs are not separated from work areas, on each floor by fire-rated construction.	Provide minimum 1.5-hr fire rated doors and seal all unprotected openings to separate the exit stairs from work areas and other building spaces on all floor levels. Ensure that the fire doors are self-closing and positive latching and that they are provided with fire exit (panic) hardware where serving production floors.	Within 3 months
-----	-------------------------	--	--	-----------------

If fire doors are required to be held open for functional reasons, provide automatic-closing devices tied to the fire alarm system.

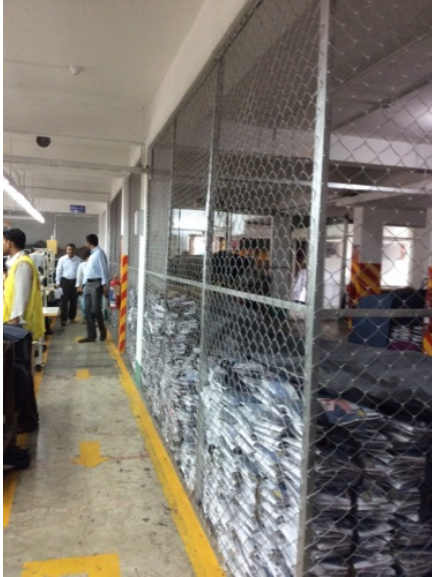
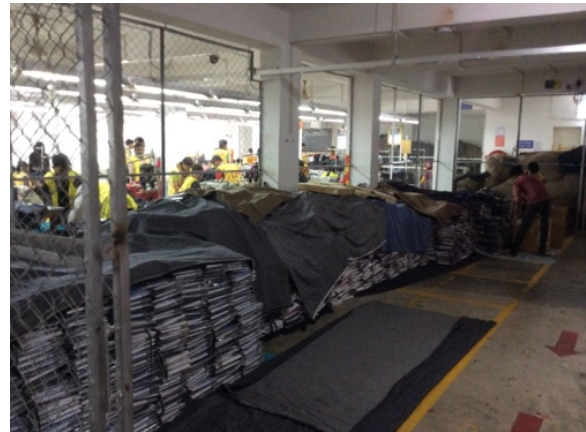
F-3	Fire Rated Construction	Areas used for combustible storage are not separated by fire-rated construction. Storage area is located in the 5th floor.	Provide dedicated storage rooms separated by minimum 1-hr fire-rated construction. Where separate storage rooms are not feasible, provide defined storage areas and limit the storage arrangement as follows: - Maximum height of 2.4m and maximum area of 23m ² - If sprinkler protected: maximum height of 3.66m and maximum area of 93m ² Separate areas of unenclosed combustible storage by a minimum clear distance of 3m.	Within 3 months
-----	-------------------------	---	--	-----------------

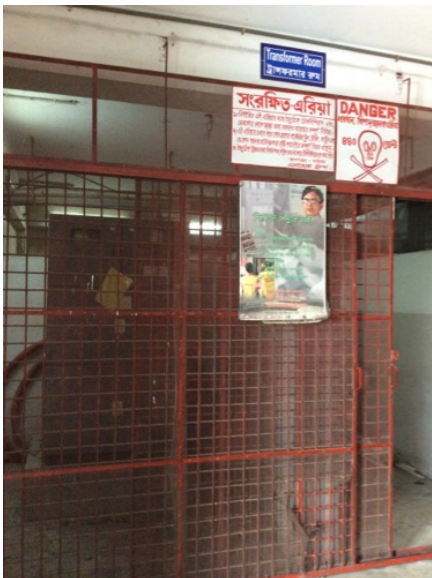
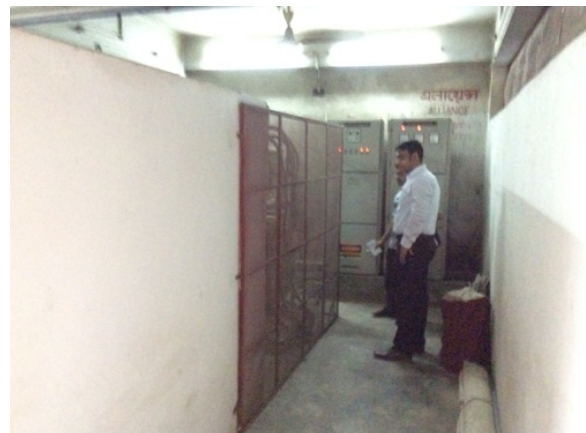
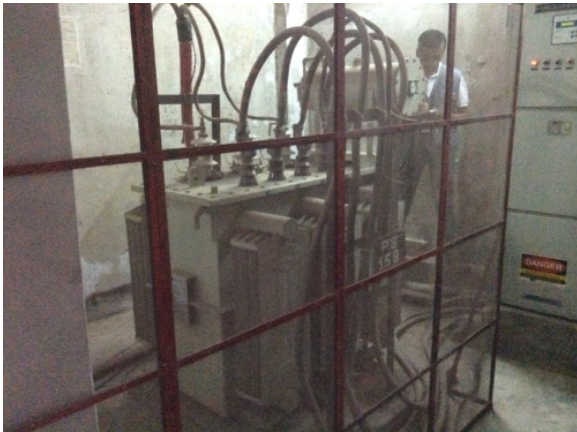
F-4	Fire Rated Construction	<p>The transformer room is not separated by fire-rated construction.</p> <p>The transformer room is located in the ground floor next to the storage room.</p>	<p>Separate the transformer room by a minimum 2-hr fire-rated construction. Seal and/or protected all openings to maintain the required fire separations</p>	<p>Within 3 months</p>
-----	-------------------------	---	--	------------------------

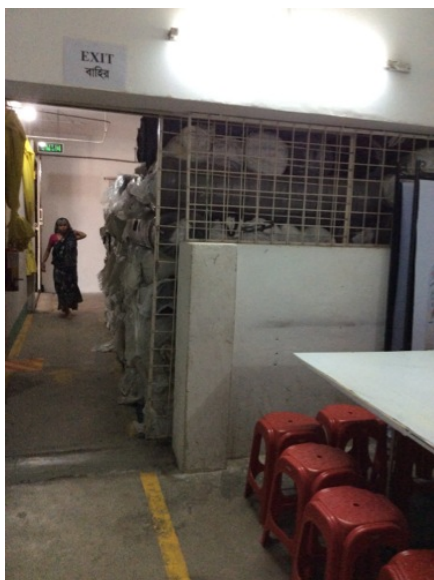
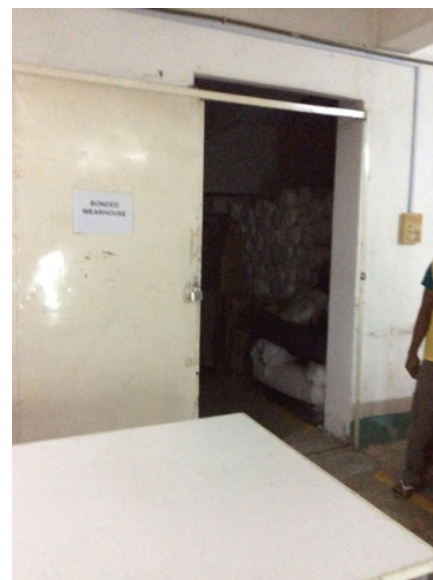
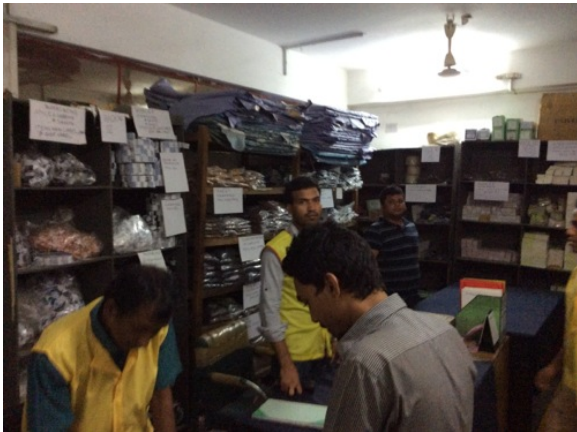
F-5	Fire Rated Construction	Storage rooms with combustible materials at ground floor were not fire separated or had unprotected openings.	Separate the storage rooms by a minimum 1-hr fire-rated construction. Provide minimum .75-hr fire rated doors and seal all unprotected openings to separate the storage rooms from work areas and other building spaces at the ground floor.	Within 3 months
-----	-------------------------	---	---	-----------------

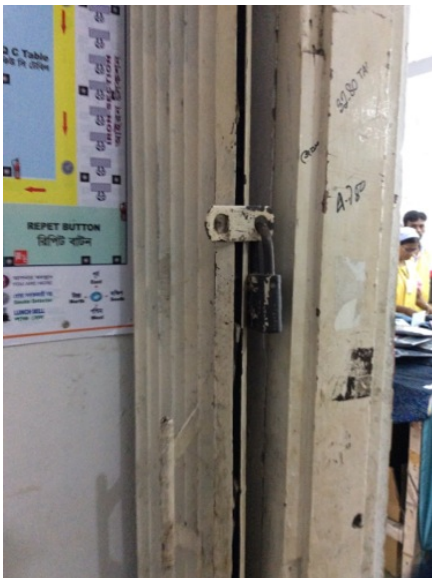
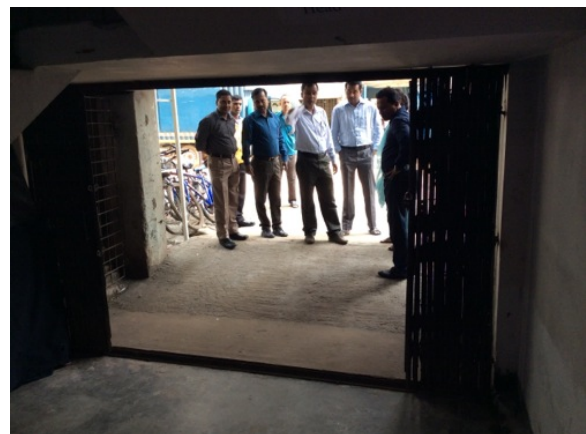
F-6 Egress

Egress doors / gates with locking features are provided at west exit stairs and exit discharge.

Remove locking features from all egress doors / gates.

Immediate

If locks are required for security reasons, utilize special door locking features complying with NFPA 101.

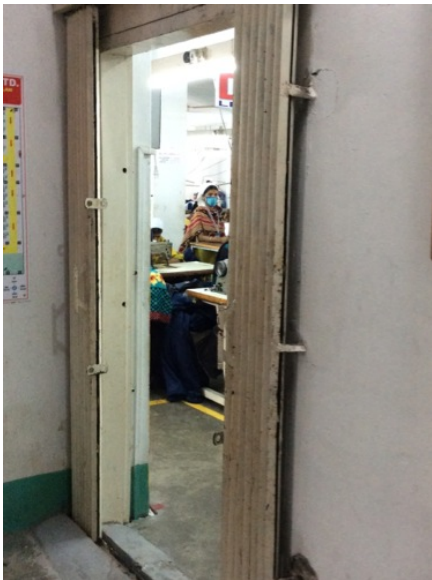
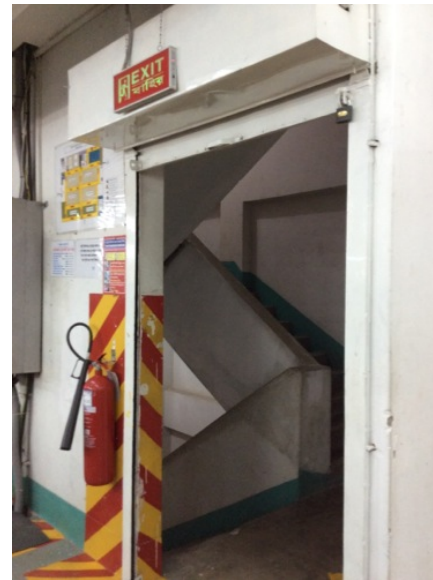
F-7	Egress	<p>Collapsible gates and roll-up doors are provided at building exits, exit stairs and exit discharge.</p> <p>Lockable sliding gates are provided at west stair and exit discharge and roll-up doors at east exit stair.</p>	<p>Replace all gates and roll-up doors along the means of egress with side-hinged, swinging egress doors.</p> <p>If locks are required for security reasons, utilize special door locking features complying with NFPA 101.</p>	Within 1 month
-----	--------	--	---	----------------

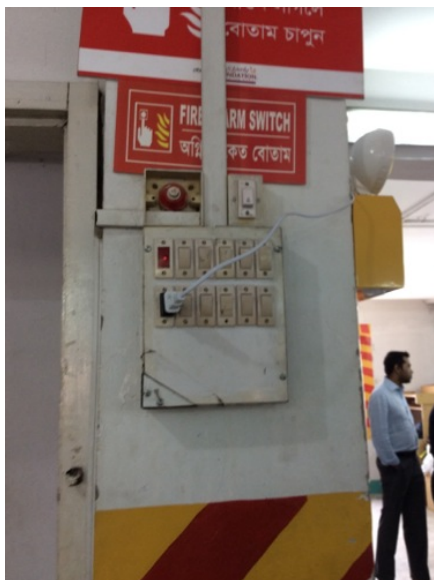
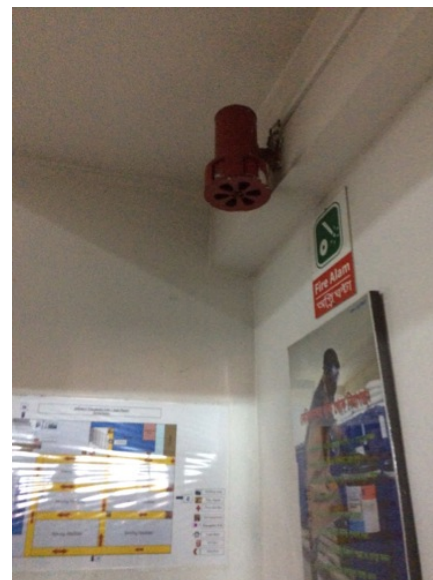
F-9	Fire Protection	The fire alarm system is antiquated, not a listed system, and does not provide alarm and notification features consistent with acceptable standards.	Replace the fire alarm system with a new, listed addressable fire alarm system in accordance with NFPA 72.	Design within 4 months, install within 9 months
-----	-----------------	--	--	---

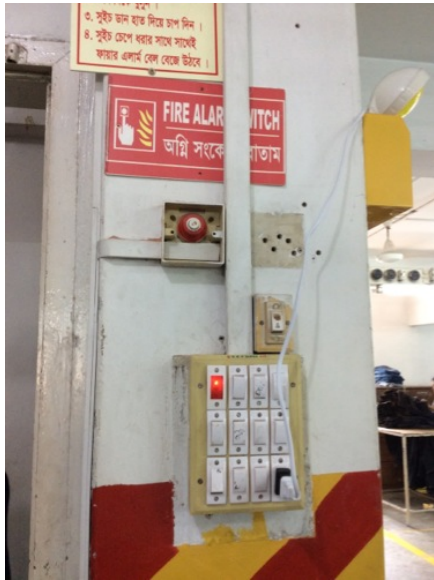
F-10	Fire Protection	Inspection, testing, and maintenance for the fire alarm system was not in accordance with NFPA 72.	Inspect, test and maintain the fire alarm system, and keep written records on-site, in accordance with NFPA 72.	Within 3 months
------	-----------------	--	---	-----------------

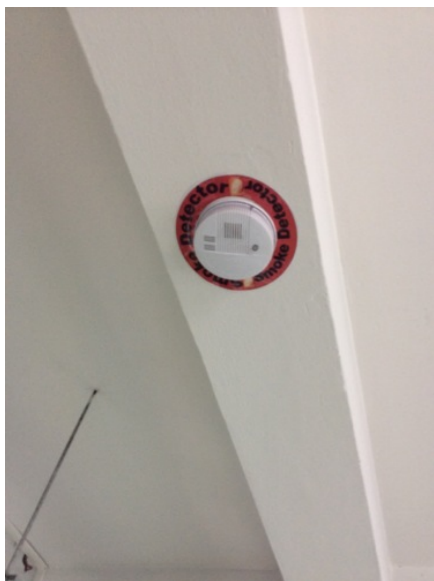
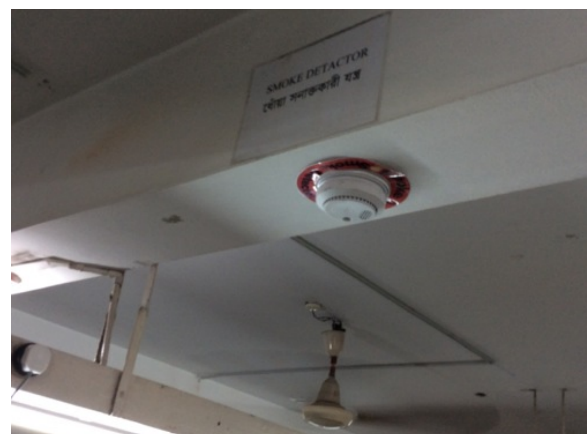
F-11	Fire Protection	The building is equipped with single-station smoke alarms. Smoke alarm activation sounds only a local alarm and does not provide automatic fire alarm notification of occupants.	Replace the single-station smoke alarms. Provide automatic smoke detection throughout the building in accordance with NFPA 72.	Within 6 months
------	-----------------	--	--	-----------------

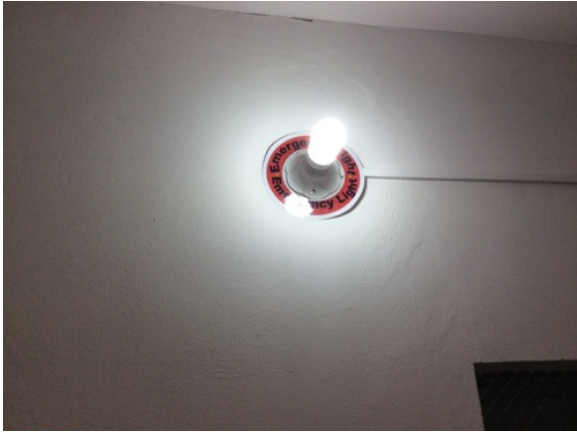
F-12	Egress Lighting	Inspection, testing, and maintenance records for the emergency lighting system were not available.	Inspect, test and maintain the emergency lighting system in accordance with The ACCORD standard. Keep written records on-site.	Within 3 months
------	-----------------	--	--	-----------------
