Alliance Garments Ltd.

20 May 2014

Structural Inspection Report

Observations & Actions

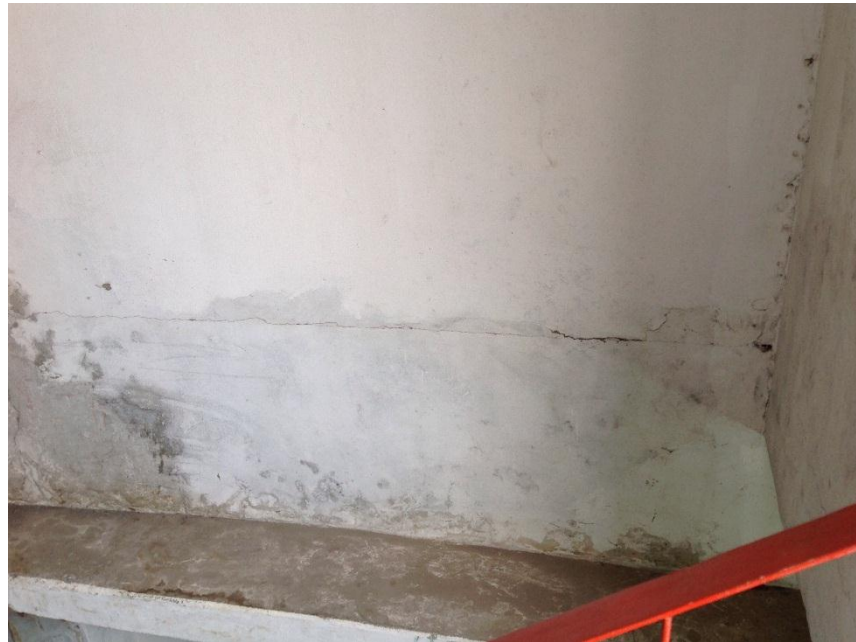
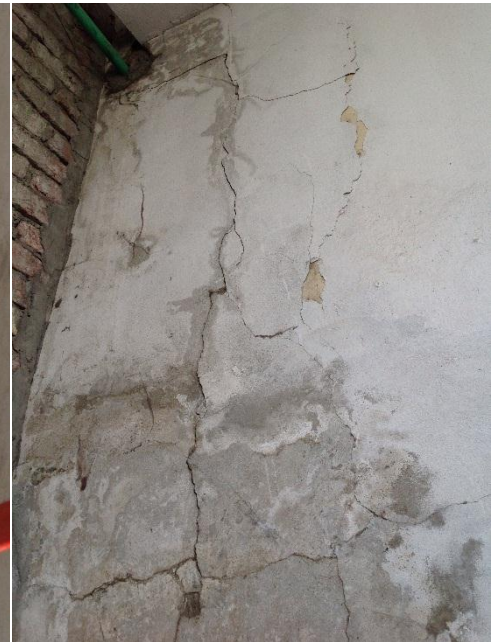
Cracking on the walls below the water tanks

Building Engineer to review structural support to concrete and plastic water tanks and confirm the adequacy of this support.

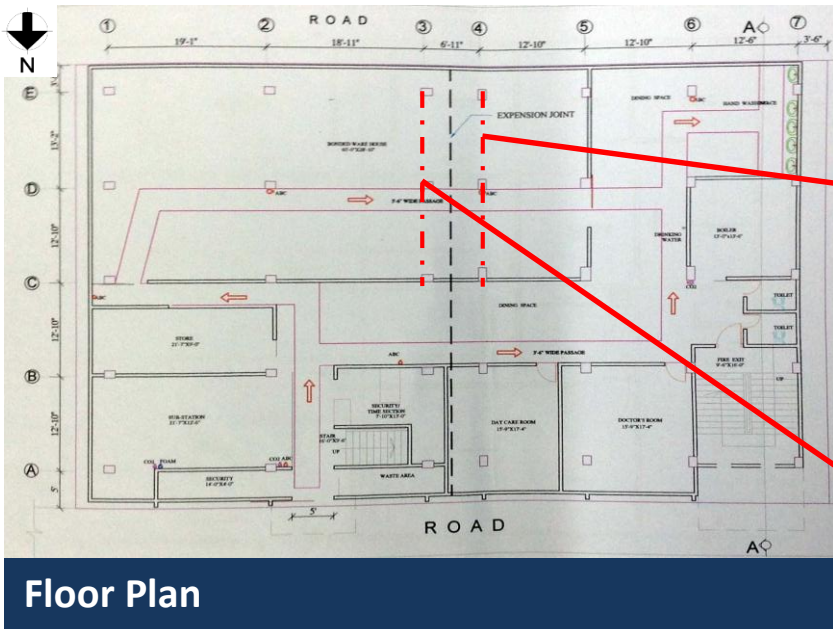
Floor Plan

Cracking to beams at underside of roof

Cracking on Soffit of Roof Beams

Cracking of beams on the soffit of the roof to be reviewed, by removing plaster, to confirm that cracks do not extend into the structure.

- Sections of plaster finish to soffit of the cracked roof beams to be removed to investigate if cracks penetrate the building structure.

- Building Engineer to carry out design check on beams to confirm that these cracks are non-structural.

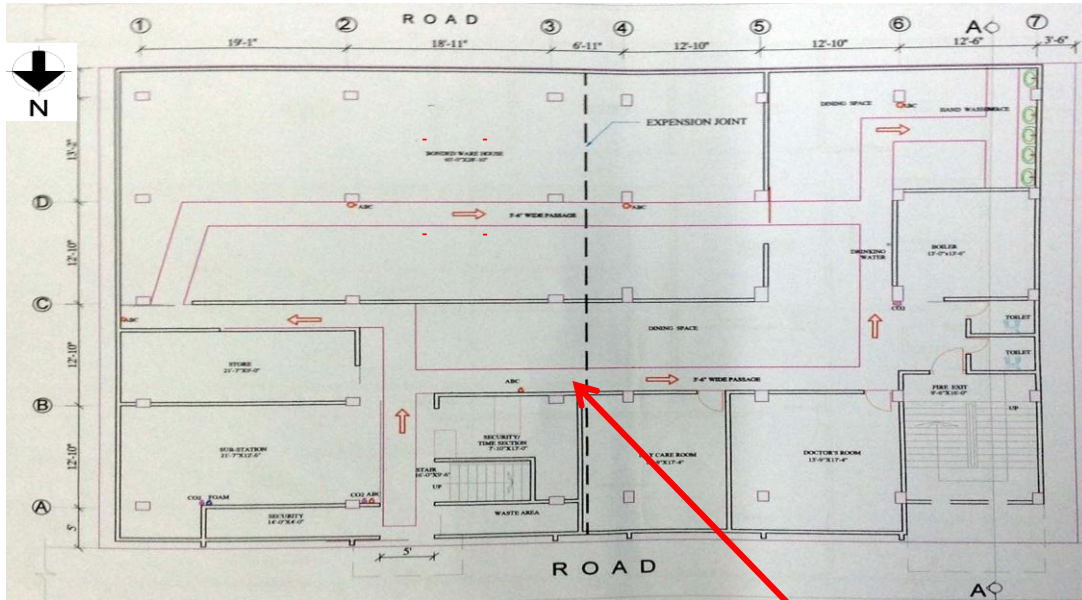
Floor Plan

Remedial work to building movement joint

Movement Joint – recommend re-weathering externally to prevent future rainwater ingress

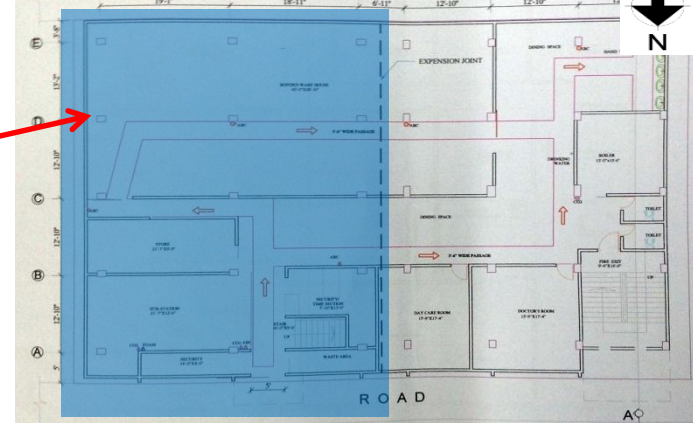
Item 1 and actions

Columns, within the eastern section of the factory, appear to be stressed in excess of normal design limits

Priority 1

(Immediate - Now)
